Job No: 11304

Job Name: Quick Mount PV On-Call Lab Testing
Walnut Creek, CA

Subject: Quick Mount PV Load Testing - Tile Replacement Mount
[QMPV# 1-28-2016-Rev C]

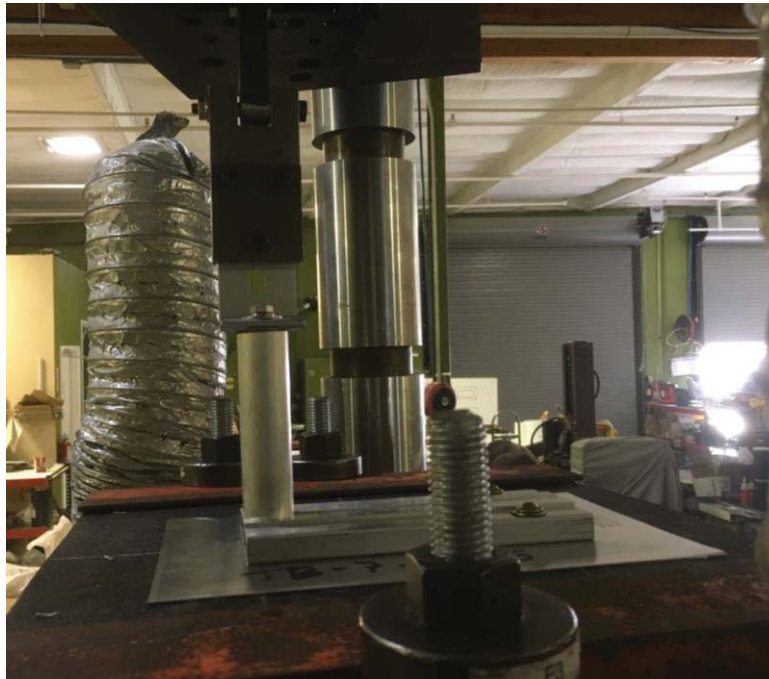
Photo 1: Tensile Eccentric Load (pre-test)

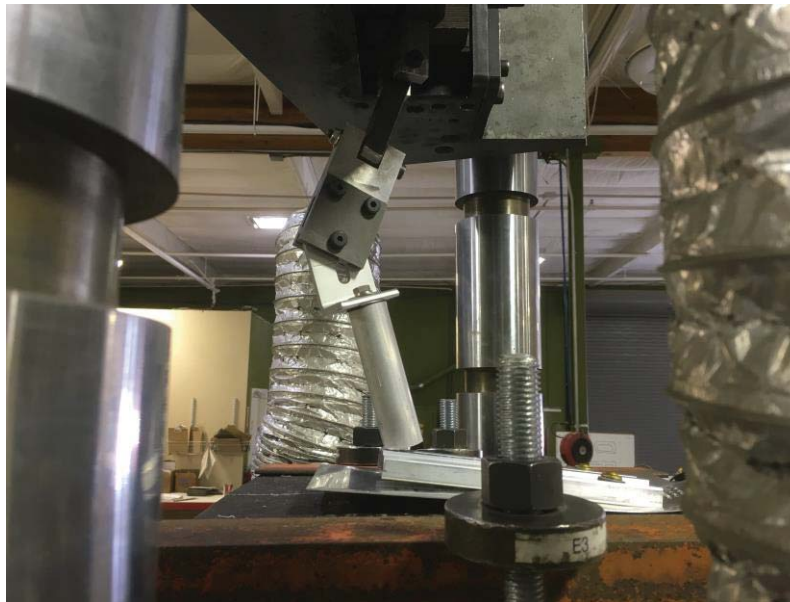
Photo 2: Tensile Eccentric Load (post-test)

Sample Number	L-Foot	Rafter Specific Gravity at Moisture	Test Rafter Moisture Content [%]	Peak Load [lbs]	Deflection at Peak Load [in]	Failure Mode
1	Unirac	0.536	12.0	1233	3.0585	Bolt Track Fractured (Al Brittle)
2	Unirac	0.505	12.5	1358	2.4038	Post Crushing (Al Ductile) / Post Hub Ruptured (Al Brittle)
3	Unirac	0.523	12.4	1508	3.0447	Steel Bolt Fractured (Steel Failure)
4	Unirac	0.513	12.7	989	2.9945	Bolt Track Fractured (Al Brittle)
5	Unirac	0.518	11.6	1396	2.9100	Post Hub Ruptured (Al Brittle)
6	Unirac	0.531	11.8	1572	3.3687	Steel Bolt Fractured (Steel Failure)
7	Unirac	0.565	11.9	1385	3.1210	Post Hub Ruptured (Al Brittle)
8	Unirac	0.503	11.0	1297	3.2010	Post Hub Ruptured (Al Brittle)
9	Unirac	0.528	12.2	1606	3.3925	Post Hub Ruptured (Al Brittle)
10	Unirac	0.531	12.3	1630	3.3555	Post Hub Ruptured (Al Brittle)
11	Unirac	0.422	11.9	1379	3.0522	Post Hub Ruptured (Al Brittle)
12	Unirac	0.504	11.0	1478	3.2952	Steel Bolt Fractured (Steel Failure)

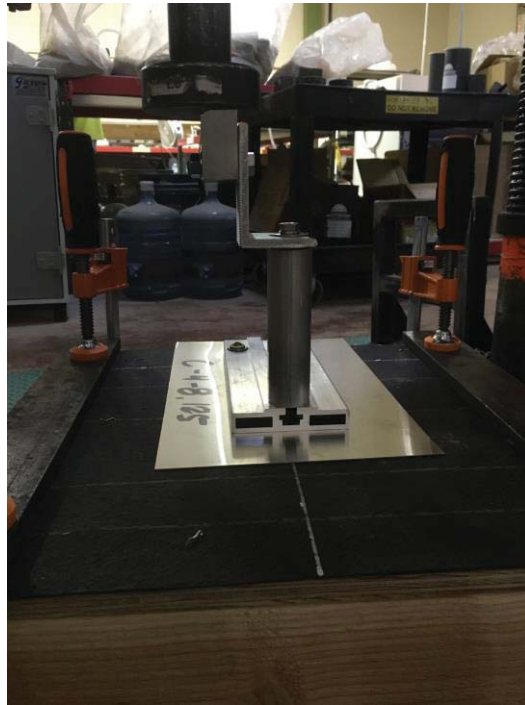
Photo 3: Compression Eccentric Load (pre-test)

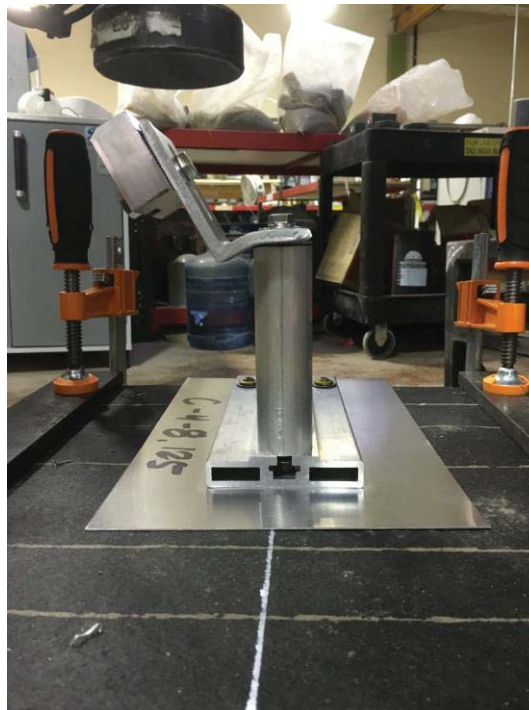
Photo 4: Compression Eccentric Load (post-test)

Sample Number	L-Foot	Rafter Specific Gravity at Moisture	Test Rafter Moisture Content [%]	Peak Load [lbs]	Deflection at Peak Load [in]	Failure Mode
1	Unirac	0.547	12.1	1096	0.4622	L-Foot Bending (Al Ductile)
2	Unirac	0.490	12.7	1173	0.5440	L-Foot Bending (Al Ductile)
3	Unirac	0.498	12.3	1083	0.5363	L-Foot Bending (Al Ductile)
4	Unirac	0.474	11.7	1241	0.5832	L-Foot Bending (Al Ductile)
Average				1117

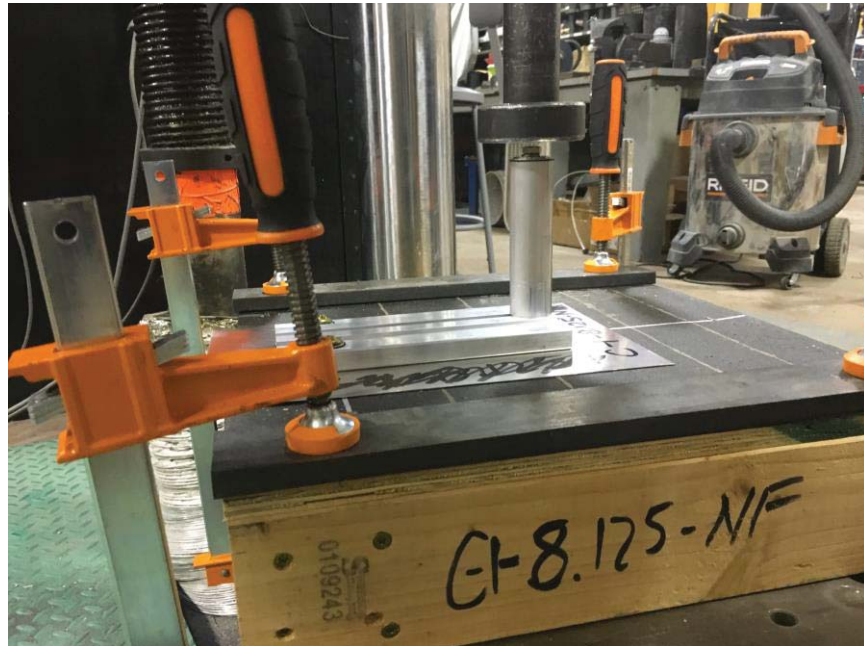
Photo 5: Compressive Eccentric Load (shown without Unirac L-foot, pre-test)

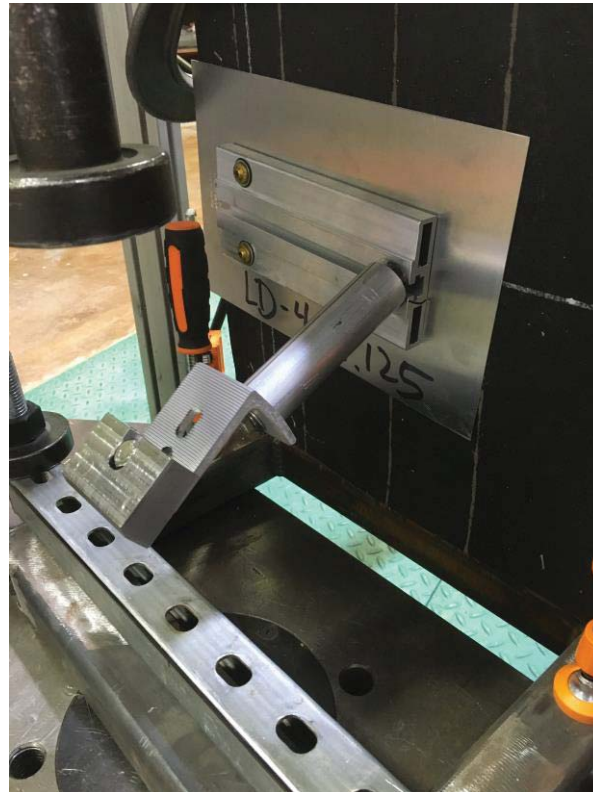
Photo 8: Lateral Parallel to Rafter Eccentric Load (post-test)

Sample Number	L-Foot	Rafter Specific Gravity at Moisture	Test Rafter Moisture Content [%]	Peak Load [lbs]	Deflection at Peak Load [in]	Failure Mode
1	Unirac	0.500	11.6	440	3.2714	Post Crushing (Al Ductile) / Post Hub Ruptured (Al Brittle)
2	Unirac	0.531	12.1	430	3.4445	Post Crushing (Al Ductile)
3	Unirac	0.514	12.5	435	3.4340	Post Crushing (Al Ductile)
4	Unirac	0.457	12.0	445	3.4195	Post Crushing (Al Ductile)
Average				438

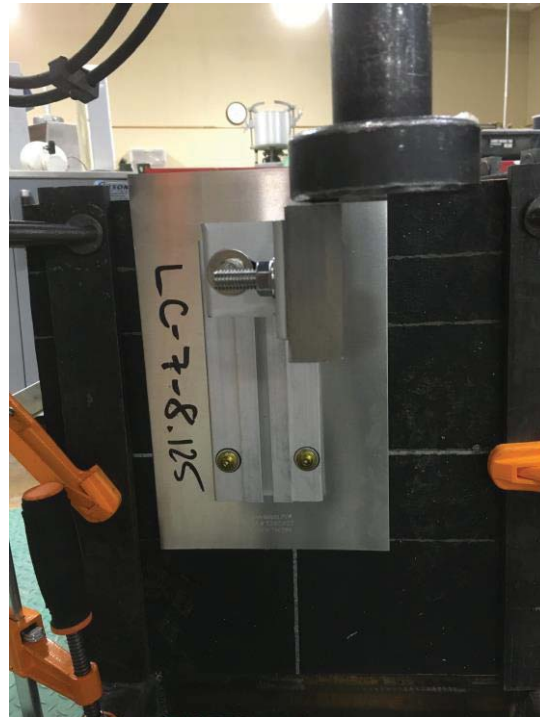
Photo 9: Lateral Perpendicular to Rafter Eccentric Load (pre-test)

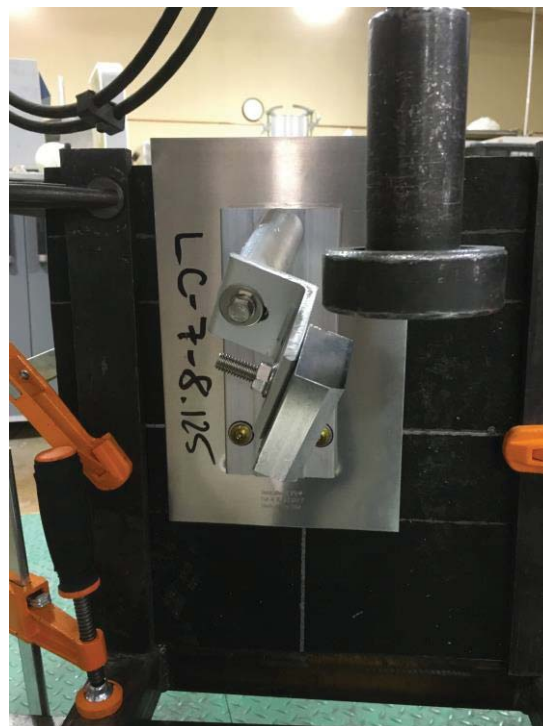
Photo 10: Lateral Perpendicular to Rafter Eccentric Load (post-test)

Sample Number	L-Foot	Rafter Specific Gravity at Moisture	Test Rafter Moisture Content [%]	Peak Load [lbs]	Deflection at Peak Load [in]	Failure Mode
1	Unirac	0.500	12.3	351	1.3575	*see note below
2	Unirac	0.508	11.8	360	2.8407	Post Crushing (Al Ductile) / Steel Bolt Fractured (Steel Failure)
3	Unirac	0.552	12.0	398	3.3868	Post Crushing (Al Ductile) / Steel Bolt Fractured (Steel Failure)
4	Unirac	0.478	12.0	362	0.4853	*see note below
5	Unirac	0.532	12.0	403	0.6180	*see note below
6	Unirac	0.513	12.4	390	3.8326	Post Hub Ruptured (Al Brittle)
Average				377

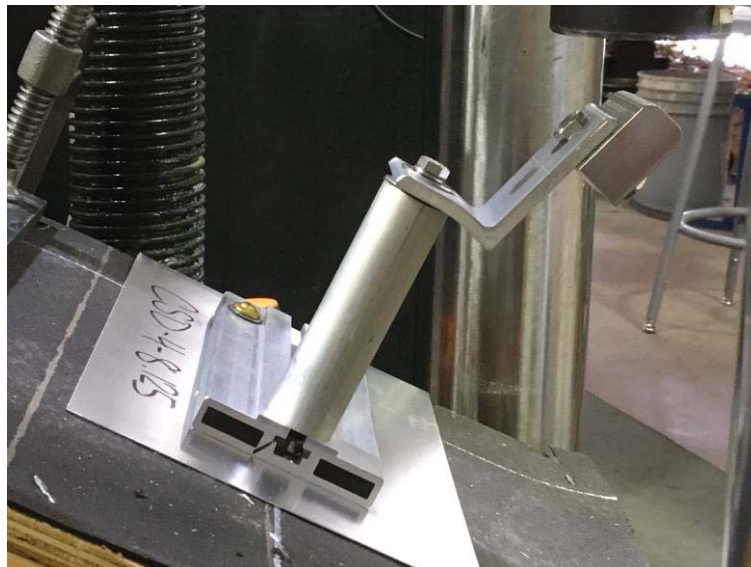
Photo 12: Resultant 6:12 Eccentric Load (Downslope, post-test)

Sample Number	L-Foot	Rafter Specific Gravity at Moisture	Test Rafter Moisture Content [%]	Peak Load [lbs]	Deflection at Peak Load [in]	Failure Mode
1	Unirac	0.487	12.5	441	1.3365	L-Foot Bending (Al Ductile)
2	Unirac	0.506	11.8	436	1.2139	L-Foot Bending (Al Ductile)
3	Unirac	0.547	11.3	433	1.1209	L-Foot Bending (Al Ductile)
4	Unirac	0.500	11.0	446	1.0705	L-Foot Bending (Al Ductile)
Average				439

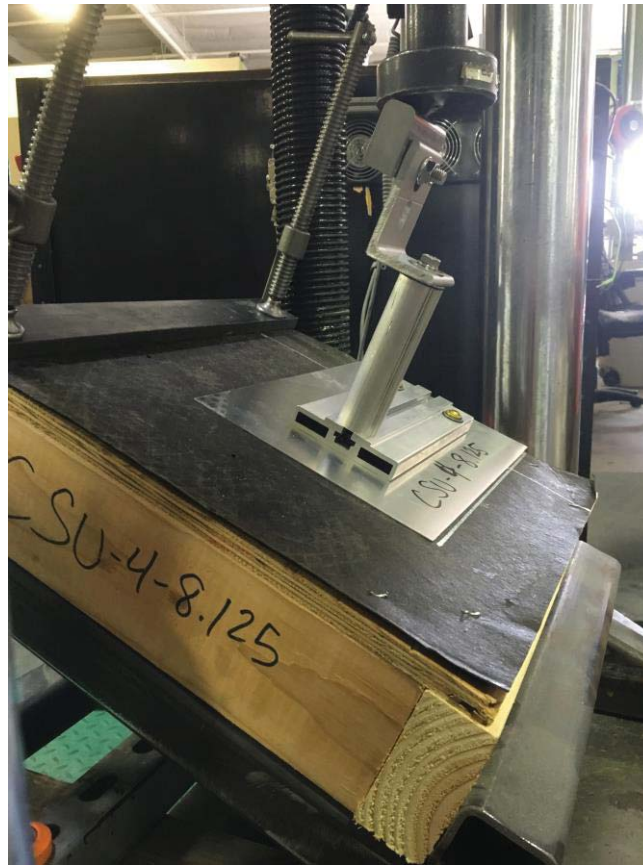
Photo 13: Resultant 6:12 Eccentric Load (Upslope, pre-test)

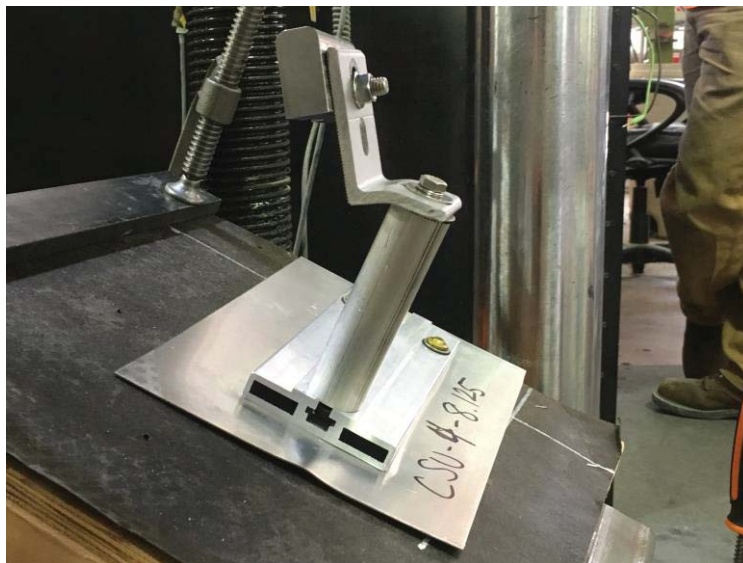
Photo 14: Resultant 6:12 Eccentric Load (Upslope, post-test)

Sample Number	L-Foot	Rafter Specific Gravity at Moisture	Test Rafter Moisture Content [%]	Peak Load [lbs]	Deflection at Peak Load [in]	Failure Mode
1	Unirac	0.472	12.4	1845	1.5212	L-Foot Bending (Al Ductile)
2	Unirac	0.436	11.8	1917	1.0633	L-Foot Bending (Al Ductile)
3	Unirac	0.472	12.4	1815	1.6158	L-Foot Bending (Al Ductile)
4	Unirac	0.515	11.1	1946	1.6303	L-Foot Bending (Al Ductile)
Average				1881
